# PRESENTATION IN ORIGINAL CONTEXTS VIA MICROCLIMATES

## ABSTRACT

English Heritage's presentation policy is to display more of its extensive collections on the sites with which they are associated. Many of the buildings have suffered the ravages of time and have far from ideal environments. A series of climate-controlled enclosures has been developed to allow safe exhibition of artefacts, while providing access to visitors who would be unlikely to visit a major museum.

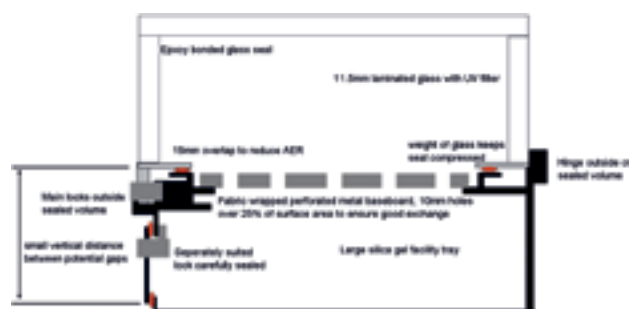
Fig. 1 Cross-section of design for low RH showcase with relevant features described.

A standard showcase has been developed to allow the provision of a low RH atmosphere (less than 30% was the aim), using passive methods for in excess of six months [6]. Many historic sites do not have ready access to power and the wide geographic dispersion of English Heritage sites and limited conservation resources mean two staff visits a year are the most that can be sustained. Details of the design principles are described in Appendix 1. A cross-section of this showcase is shown in Fig. 1.

A lower back-hinged glass desktop case design was selected to lower AER. This has a single level seal, reducing air infiltration from the stack effect engendered by two vertically-separated horizontal cracks [16]. The glass lid had an internal metal flange around its lower edge. This mated to a flanged metal profile, such that the compression seal was compressed by the weight of the glass lid. Any air movement through that seal went through a 1 cm deep narrow horizontal gap between the two metal fittings.

The silica gel tray was placed directly underneath the display volume to reduce the vertical separation between the seals in its separate door and the glass seals. The heat gain inside the showcase is kept low by excluding internal lighting, and careful positioning to reduce heating from either windows or other display lighting.

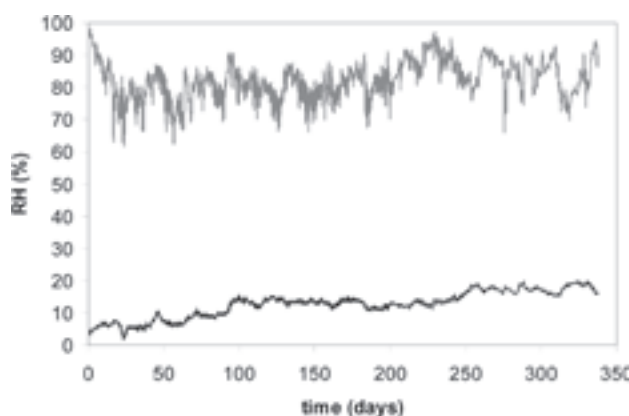
Fig. 2 Performance of low RH showcase, atmosphere below 20% is maintained for almost one year.

Over 30 such cases have now been installed at nine different sites and careful quality control (all cases have their air exchange rate tested as they are installed) has meant all the cases have AERs of less than  $0.4 \text{ day}^{-1}$  and the RH is consistently controlled below 30%. Fig. 2 shows the room RH and RH inside a representative case at Pevensey Castle.

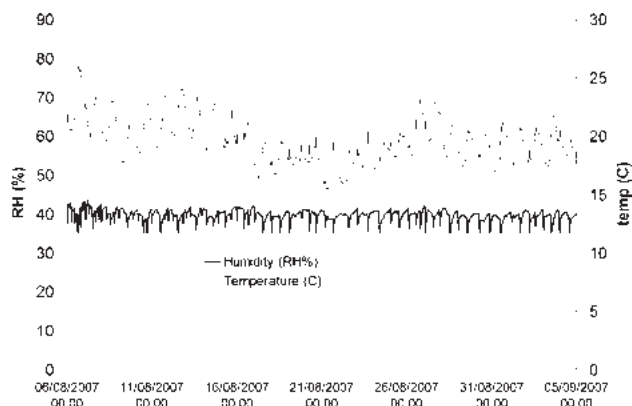
Fig. 3 Performance of dehumidifier controlled showcase at Yarmouth Castle.

temperatures sometimes experienced in March on opening the castle. The environment achieved inside the case is shown in Fig. 3. The high leakage rate of the case and significant overcapacity of the dehumidification led to characteristic RH cycles. Attempts to improve the sealing of the case and baffle the dehumidifier output are under way to reduce this effect.

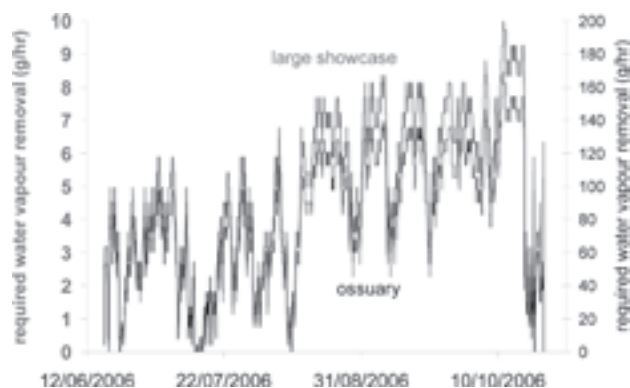
Fig. 4 Dehumidification requirements for control below 65% for large showcase and ossuary at St Peter's, Barton-upon-Humber.

Human remains from archaeological excavations at the deconsecrated church of St Peter's Church, Barton-upon-Humber, have formed an incredibly important study collection for osteo-archaeology since the 1950s. The spread of dates, sexes and ages of the skeletons has provided an unparalleled study set. A project to interpret this in the church and install an ossuary in the organ chamber, to store safely the 3000 remains and allow study access, was completed in 2007. In both spaces the high RH presented a mould risk, particularly in the still air of showcases/storage boxes. The temperature and RH in both spaces was monitored prior to the project, to determine the required dehumidification load to achieve 65% RH, either in the organ chamber or inside showcases, with air exchange rates below two per day. The amount of air ingressing the enclosure was calculated for one-hour intervals using the air exchange rate and volumes. The difference in absolute humidity between the room and the enclosure at the same temperature and 65% RH was calculated and combined with the amount of air ingressing, to calculate the amount of water vapour that would need to be removed from the enclosure volume to keep the RH below 65%. Results for the largest showcase and the ossuary are shown in Fig. 4.

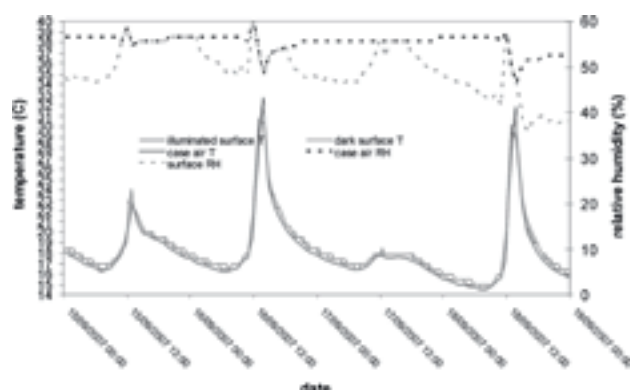
Fig. 5 Surface temperatures and RHs of bones illuminated through un-filmed windows at St Peter's, Barton-upon-Humber.

The showcase glass includes a laminated ultraviolet (UV) film, protecting the bone and wooden coffin artefacts. No significant thermal gain was observed in the monitoring from the showcases. However, there was concern that surface heating of the bones could reduce their surface humidity to unacceptable levels and lead to deterioration. Many of the bones are stained black from tannic acid leaching out of their oak coffins, decreasing their albedo and increasing their propensity to heat under illumination. The surface temperature of bones in the showcase suffering illumination from the south-facing windows was measured with Pt 1000 surface resistance probes. The probes were tied onto the bone to ensure good thermal contact, with one probe illuminated and the second positioned on the dark side of the bone. Air temperature and RH were monitored directly adjacent to the bone, as were the illumination levels. The surface RH was calculated from the absolute humidity and surface temperature, as described by Schellen [8]. The monitoring, Fig. 5, showed that although the bones did suffer from photo-thermal heating, the surface RHs were well above the 35% that has been recommended for storage of such material [9].

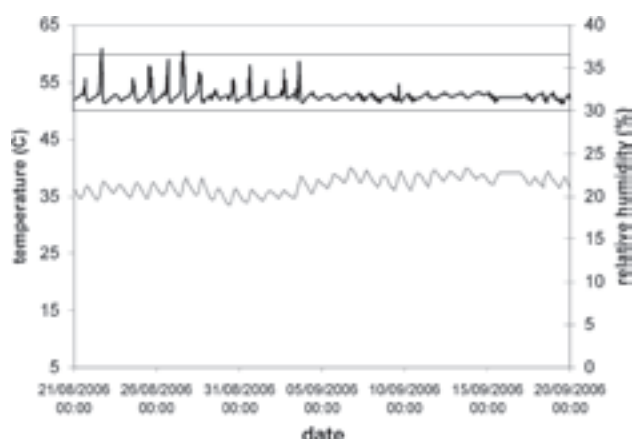
Fig. 6 Performance of tapestry showcase in Leicester's Gatehouse at Kenilworth Castle, before fitting of additional fan.

The conditions achieved in the showcases are tabulated in Table 1. The majority of the cases easily met the loan specifications. The tapestry case initially showed short-lived RH peaks around 4 p.m. on most days, taking it out of specification, see Fig. 6. No obvious temperature perturbation was associated with these RH changes. Sunlight had been observed to strike the plinth containing the Miniclimate unit at around this time in the afternoon during installation, before the blinds were lowered. It was postulated that the sun was heating the blind and although visible light was kept below 200 lux, infrared emission from the heated blind was heating the dark brown plinth. The surface temperature was measured on the outside and inside of the plinth using Pt 1000 sensors and a SR007 datalogger, and the internal air temperature inside the plinth was monitored with a Meaco transmitter. The external temperature of the plinth was observed to rise dramatically by almost  $4^\circ\text{C}$  at the expected time. This was followed several minutes later by a smaller temperature rise on the internal surface and then by a rise in the air temperature inside the plinth. This temperature rise reduces the efficiency of the Peltier unit used for dehumidification in the Miniclimate and the RH in the case rises. The problem was solved by adding two fans to the plinth casing to ensure sufficient air-flow to remove the heat swiftly. This work was undertaken on 4 September 2006 and the improvement in the conditions is clear in Fig. 6.

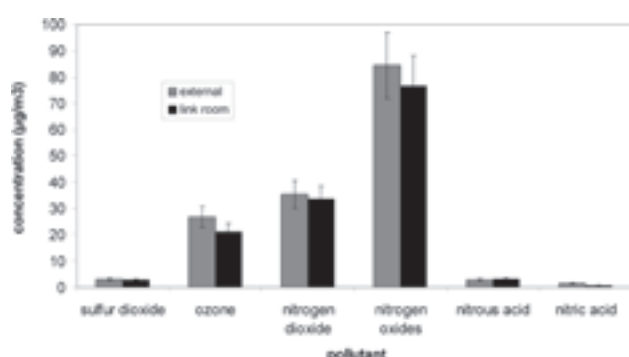
Fig. 7 Pollution ingress into link building at Chiswick House.

House in West London has a major road nearby, generating high concentrations of nitrogen oxides and ozone. The original large gateways in the ground floor link-room have been glazed with Perspex. Measurements of the ventilation rates of the building showed over 10% of the overall ventilation occurred through this small part of the building, bringing in high pollutant gas concentrations. The concentrations of sulphur dioxide, nitrogen dioxide, nitric and nitrous acid and ozone were measured as part of the Microclimate Indoor Monitoring for Cultural Heritage Preservation (MIMIC) project. One month's results are shown in Fig. 7. As can be seen, this part of the building provides very little protection, with indoor/outdoor ratios of all pollutants exceeding 66%. The room values for sulphur dioxide, nitrogen dioxide and ozone all generally exceeded those recommended for the display of graphic material. Recommendations do not presently exist for nitrous and nitric acid, although much of the damage previously attributed to nitrogen dioxide is now thought to have been caused by nitric acid [11]. The protective effects of the print frames in this room were investigated.

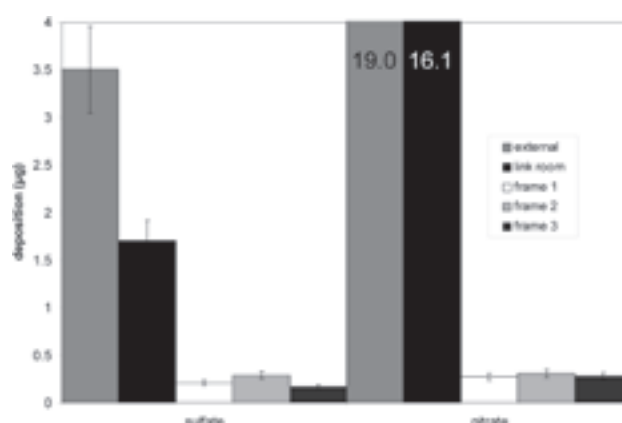
Fig. 8 Protection of print frames against pollution deposition in link building at Chiswick House.

rates, compared with the room values, with over 90% reduction in sulphate and 98% reduction in nitrate, see Fig. 8. The reductions followed the air exchange rates, with greater reductions occurring for lower air exchange rates, as would be expected with frames of similar size, constructed with the same materials.
