## MANAGING NATURAL LIGHT IN HISTORIC PROPERTIES

David Thickett<sup>1</sup>

### ABSTRACT

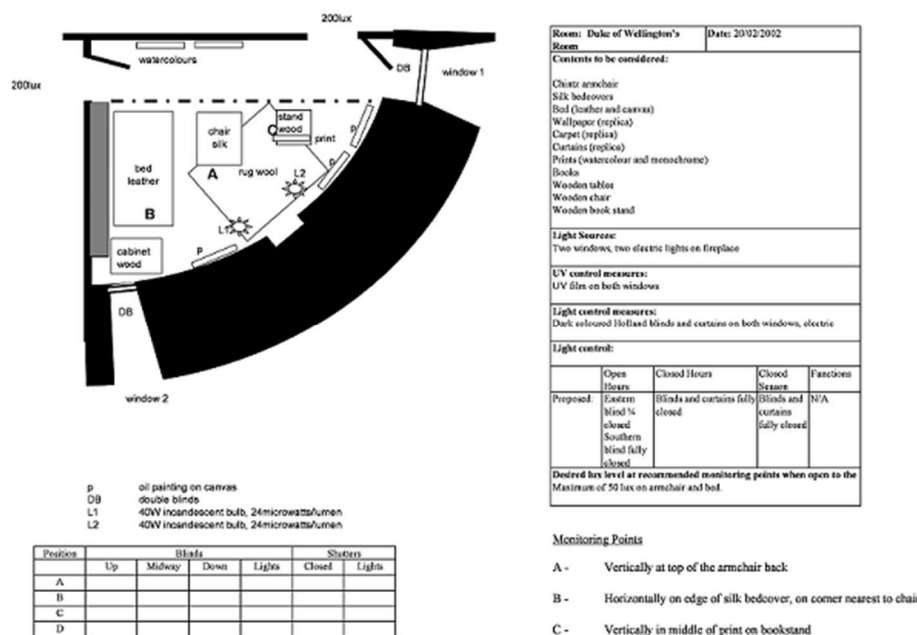
FIG. 1 – Example of a light plan.

Light plans have been developed by several institutions to manage daylight. Essentially, a large number of measurements are taken ideally over several months. These guide the selection of measurement points that are then used to manually adjust the blinds and any artificial lights present to achieve set lux levels. Overall, the objective is to achieve a particular annual dose across a collection in a room. The plans often include indicative blind positions, sometimes for different times of the year and different sky conditions. An example is shown as FIG. 1.

Selection of the measuring points is critical. Two general approaches have been used. If the room contains a particularly significant or vulnerable object, then this can be defined as one of the points. The alternative is to try to define representative points.

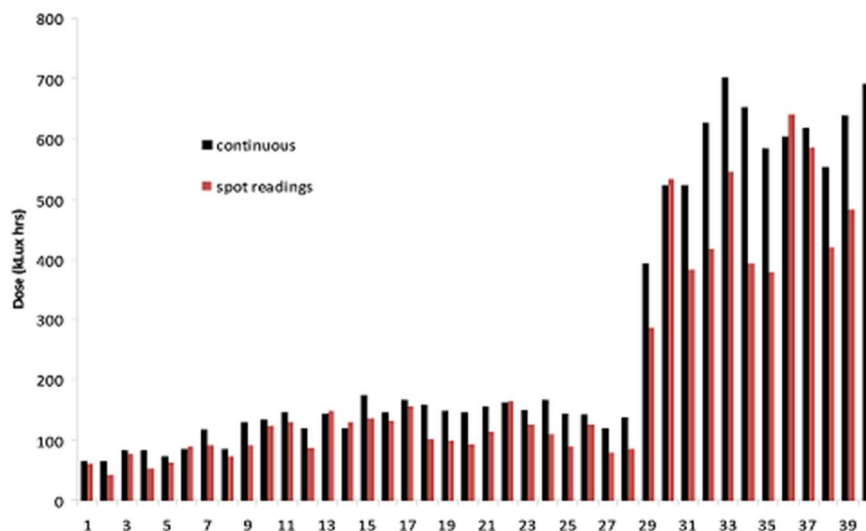
FIG. 2 - Doses from daily readings.

data files from six English Heritage properties were examined. Annual lux doses were calculated from the hourly data. The data was then reduced such that readings from 9am, 12am and 3pm only were used to generate the annual exposure. The calculated doses are shown in FIG. 2.

As can be seen, the spot readings differ significantly from the continuous doses, by up to 36%. In most instances (85%) they are lower and frequently much lower, which would give a falsely reassuring estimate of the light exposure.

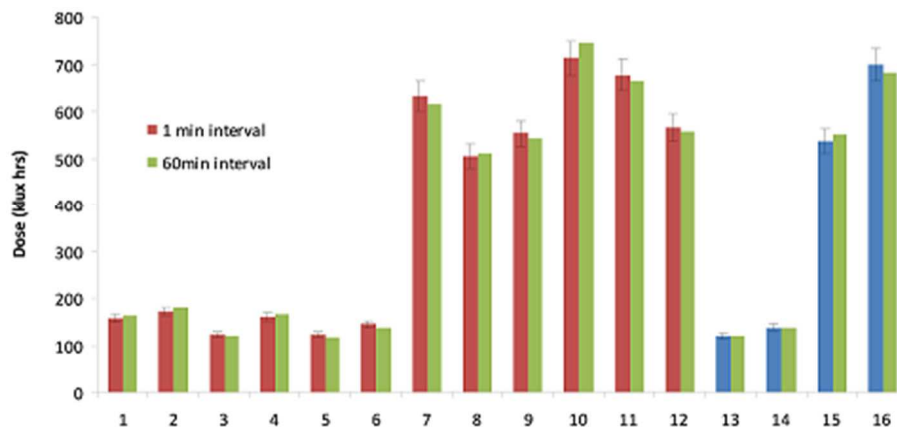
FIG. 3 - Doses from collecting data continuously, every minute and every hour.

The doses measured, using different intervals of the data and with the proportional dose monitor (FIG. 3), show less than 5% difference.

The frequency of measurement for automatic equipment appears to have little affect when above hourly. However, where blinds, shutters or curtains are used the relative timing of measurements can dramatically affect the dose, especially with limited opening hours. For example, if a room has the shutters open four hours a day, the measurement interval is hourly, on the hour and the shutters are opened at 12.01 and closed at 15.59, the dose will be underestimated by almost 50%.

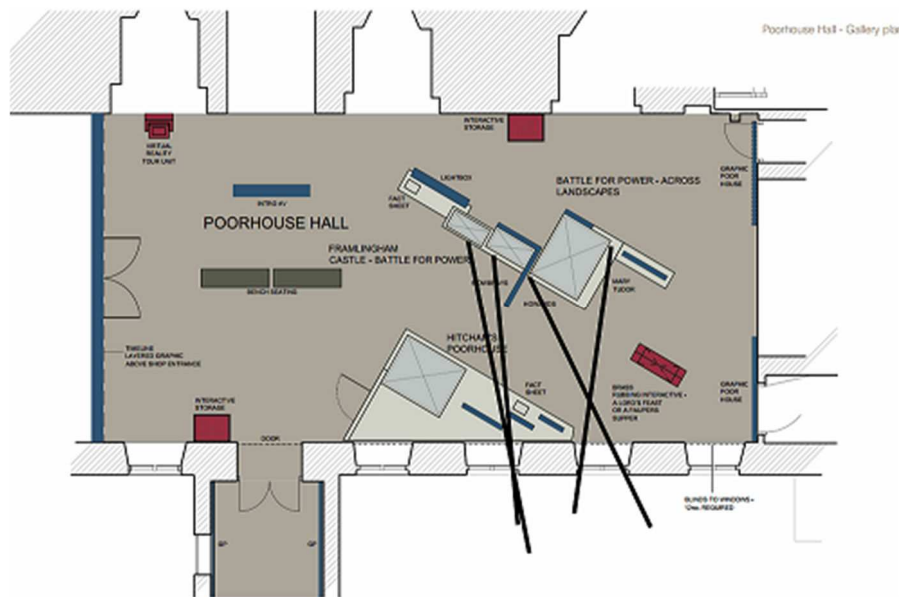
FIG. 4 - Framlingham.

Within English Heritage's estate, many historic properties now contain showcases. Careful design is required to ensure adequate showcase performance environmentally. In such situations, the room environments are frequently far from ideal, and showcases are often required to perform significant environmental remediation for safe display of their contents. At St Peters church, the surface temperature of archaeological bone displayed in showcases under stained glass windows found to have significant daily increases with predicted decreases in surface RH, within 2% of damaging levels (Thickett, 2008). This emphasizes the care needed with such situations. The intrinsic nature of historic properties can limit installation of light control. The stained glass could not have films adhered to it, the window framing was architecturally important, so blinds could not be fitted, and the light filtering through the stained glass was thought an essential component of the interior. Simple geometry can indicate when direct sunlight can fall on showcases, FIG. 4. As described previously, mobile apps can dramatically reduce the time needed for calculations.

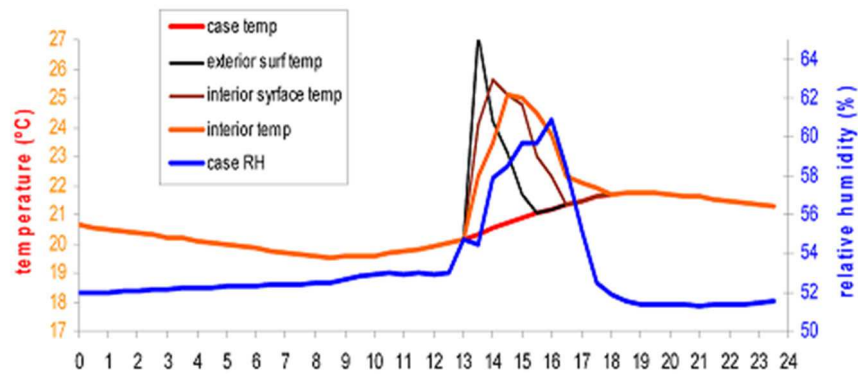
FIG. 5 - Kenilworth.

Although visible light was kept below 200lux, it was suspected that infrared emission from the heated blind was heating the dark brown plinth. The surface temperature was measured on the outside and inside of the plinth using Pt 100 sensors and a SR007 datalogger, and the internal air temperature inside the plinth was monitored with a Meaco transmitter. FIG. 5 shows a 24-hour period with the effect observed.

As can be seen, the exterior surface temperature of the plinth rises sharply around one pm. The interior surface temperature follows this increase more slowly and is heated for longer. The air temperature inside the plinth rises by 3°C and the RH in the case rises. The problem was solved by adding two fans to the plinth casing to ensure sufficient air-flow to remove the heat swiftly. Opening the view from the window with the mesh did not impact on the case performance with the fans running.

The majority of the cases easily met the loan specifications. One showcase initially showed short-lived RH peaks between 2 and 4 p.m. on most days, taking it out of specification for the loan object in it. No obvious temperature perturbation was associated with these RH changes. Sunlight had been observed to strike the plinth containing the Miniclimate unit at around this time in the afternoon during installation, before the blinds were lowered.

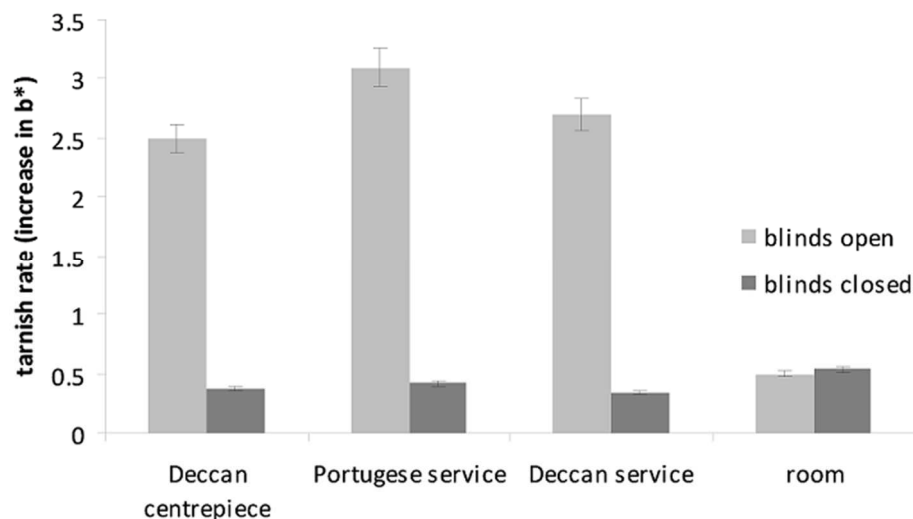
FIG. 5 – Silver tarnish.

relatively expensive to achieve. FIG. 6 and 7 show the silver tarnish rate and hydrogen sulfide concentration in showcases, between windows for 30 day periods under the old regime, with the blinds raised and the new regime using the light plan.

As can be seen, the hydrogen sulfide and tarnish rates are significantly higher when the showcases are exposed to UV filtered sunlight. The hydrogen sulfide and tarnish rates are similar in the room over the two periods. To further investigate small samples of the blue fabric were taken from areas exposed to light and those under card labels. The

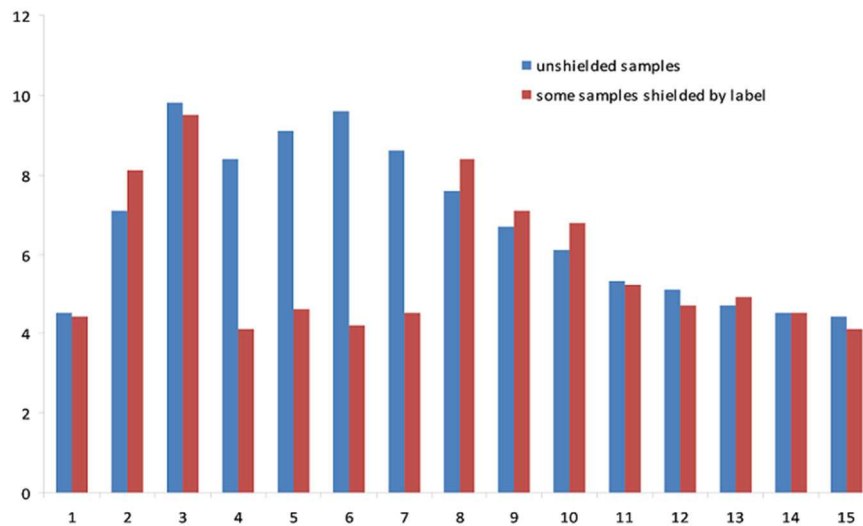
FIG. 7 - Cysteic acid area.

samples were analysed with Fourier transform infra-red spectroscopy and the area of the cysteic acid peak in the second derivative at  $1046\text{cm}^{-1}$  determined as a measure of wool degradation (Odlyha et al., 2007). Results are shown in FIG. 7.

Points 2-11 experience sunlight, whilst points 1 is shielded by the case frame and points 4-7 are under a label. The unexposed wool is significantly less chemically degraded.
